**PHOTOGRAPHIC  
EVALUATION REPORT  
MISSION 1029-1  
2-7 FEBRUARY 1966  
MISSION 1029-2  
8-12 FEBRUARY 1966**

JULY 1966

NATIONAL PHOTOGRAPHIC INTERPRETATION CENTER

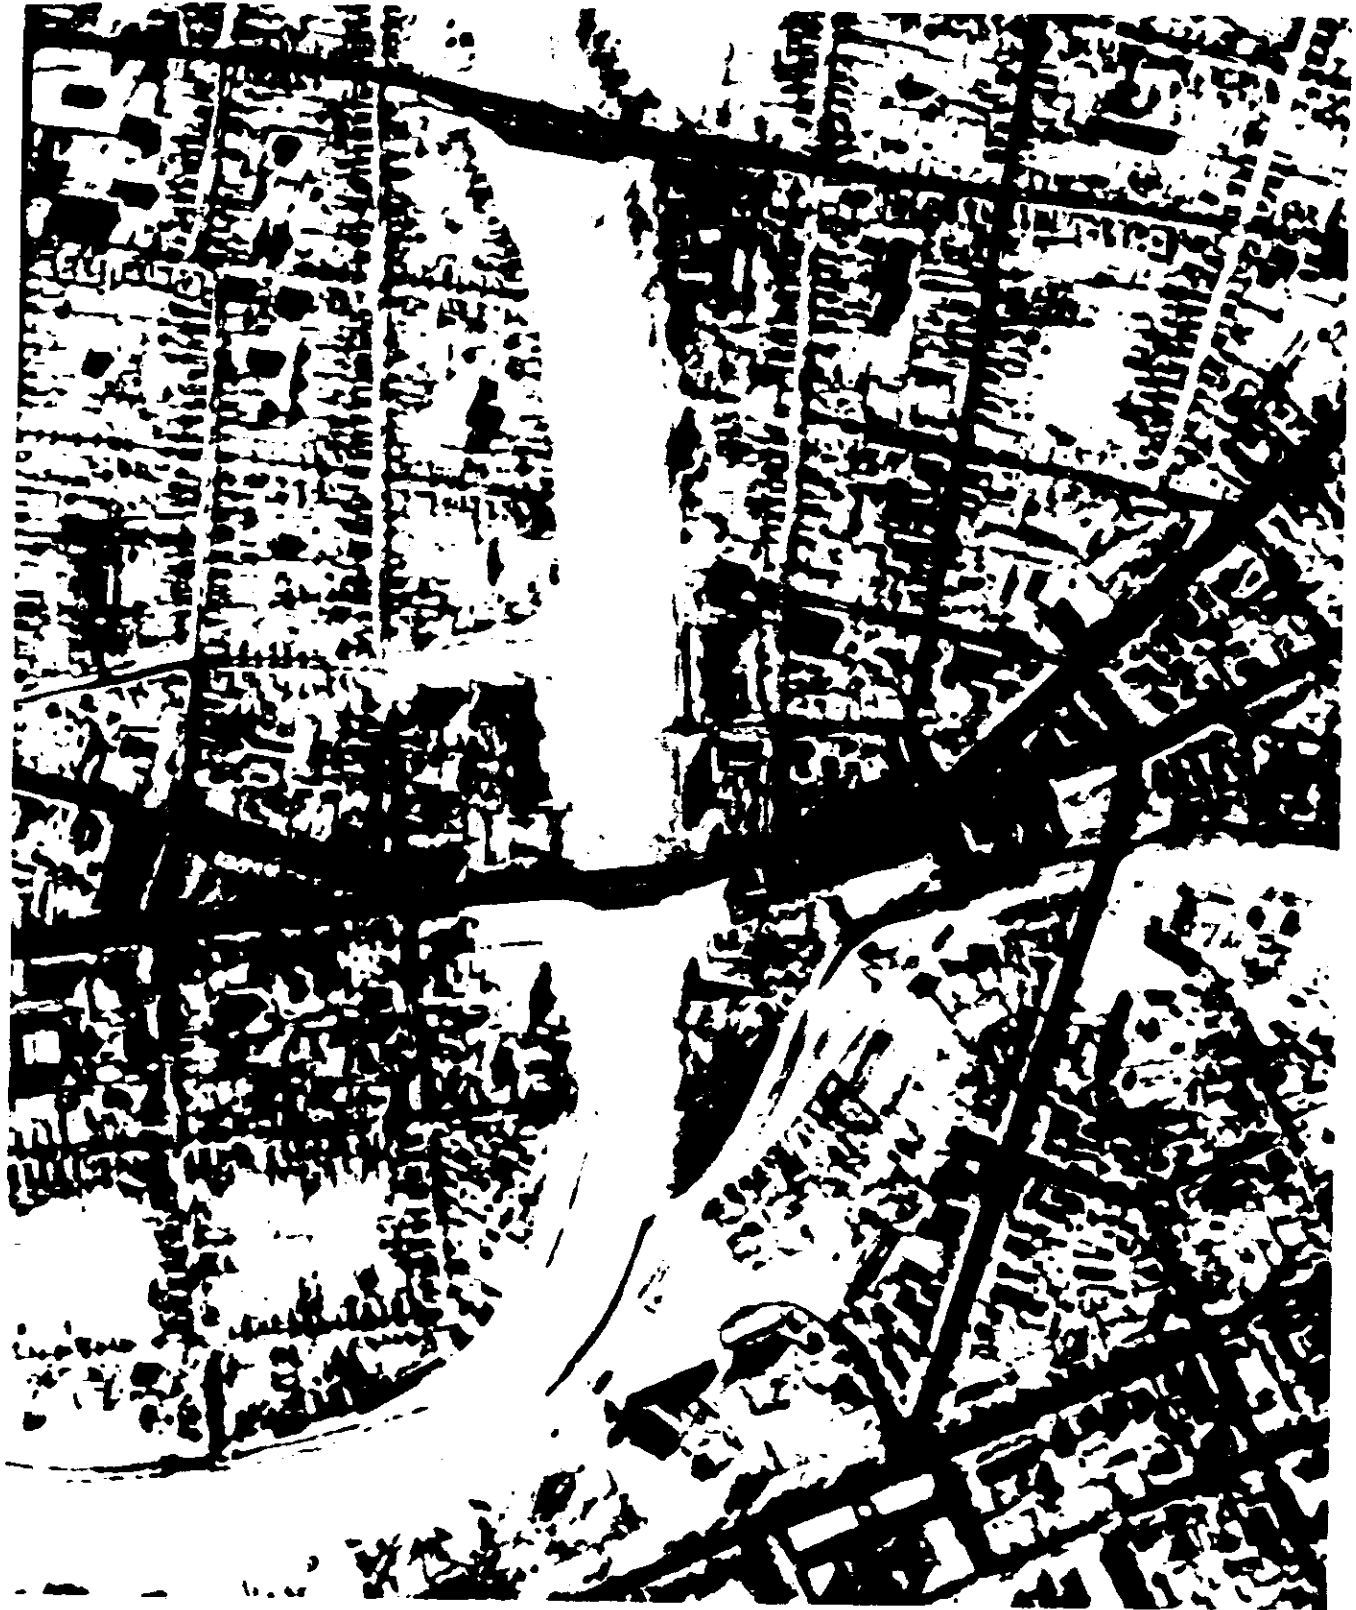
FIGURE 8. IMAGE DEGRADATION CAUSED BY BLOWING SNOW

Photointerpreters reported that blowing snow in this part of the mission caused the PI suitability to be poor.

The photointerpreters specifically mentioned the beginning of pass 24D as an example of image degradation associated with low solar elevation. The last few frames on pass 144D were given as an example of image degradation associated with blowing snow. The photointerpreters mentioned the photography on pass 103D as an example of imagery degraded by haze.

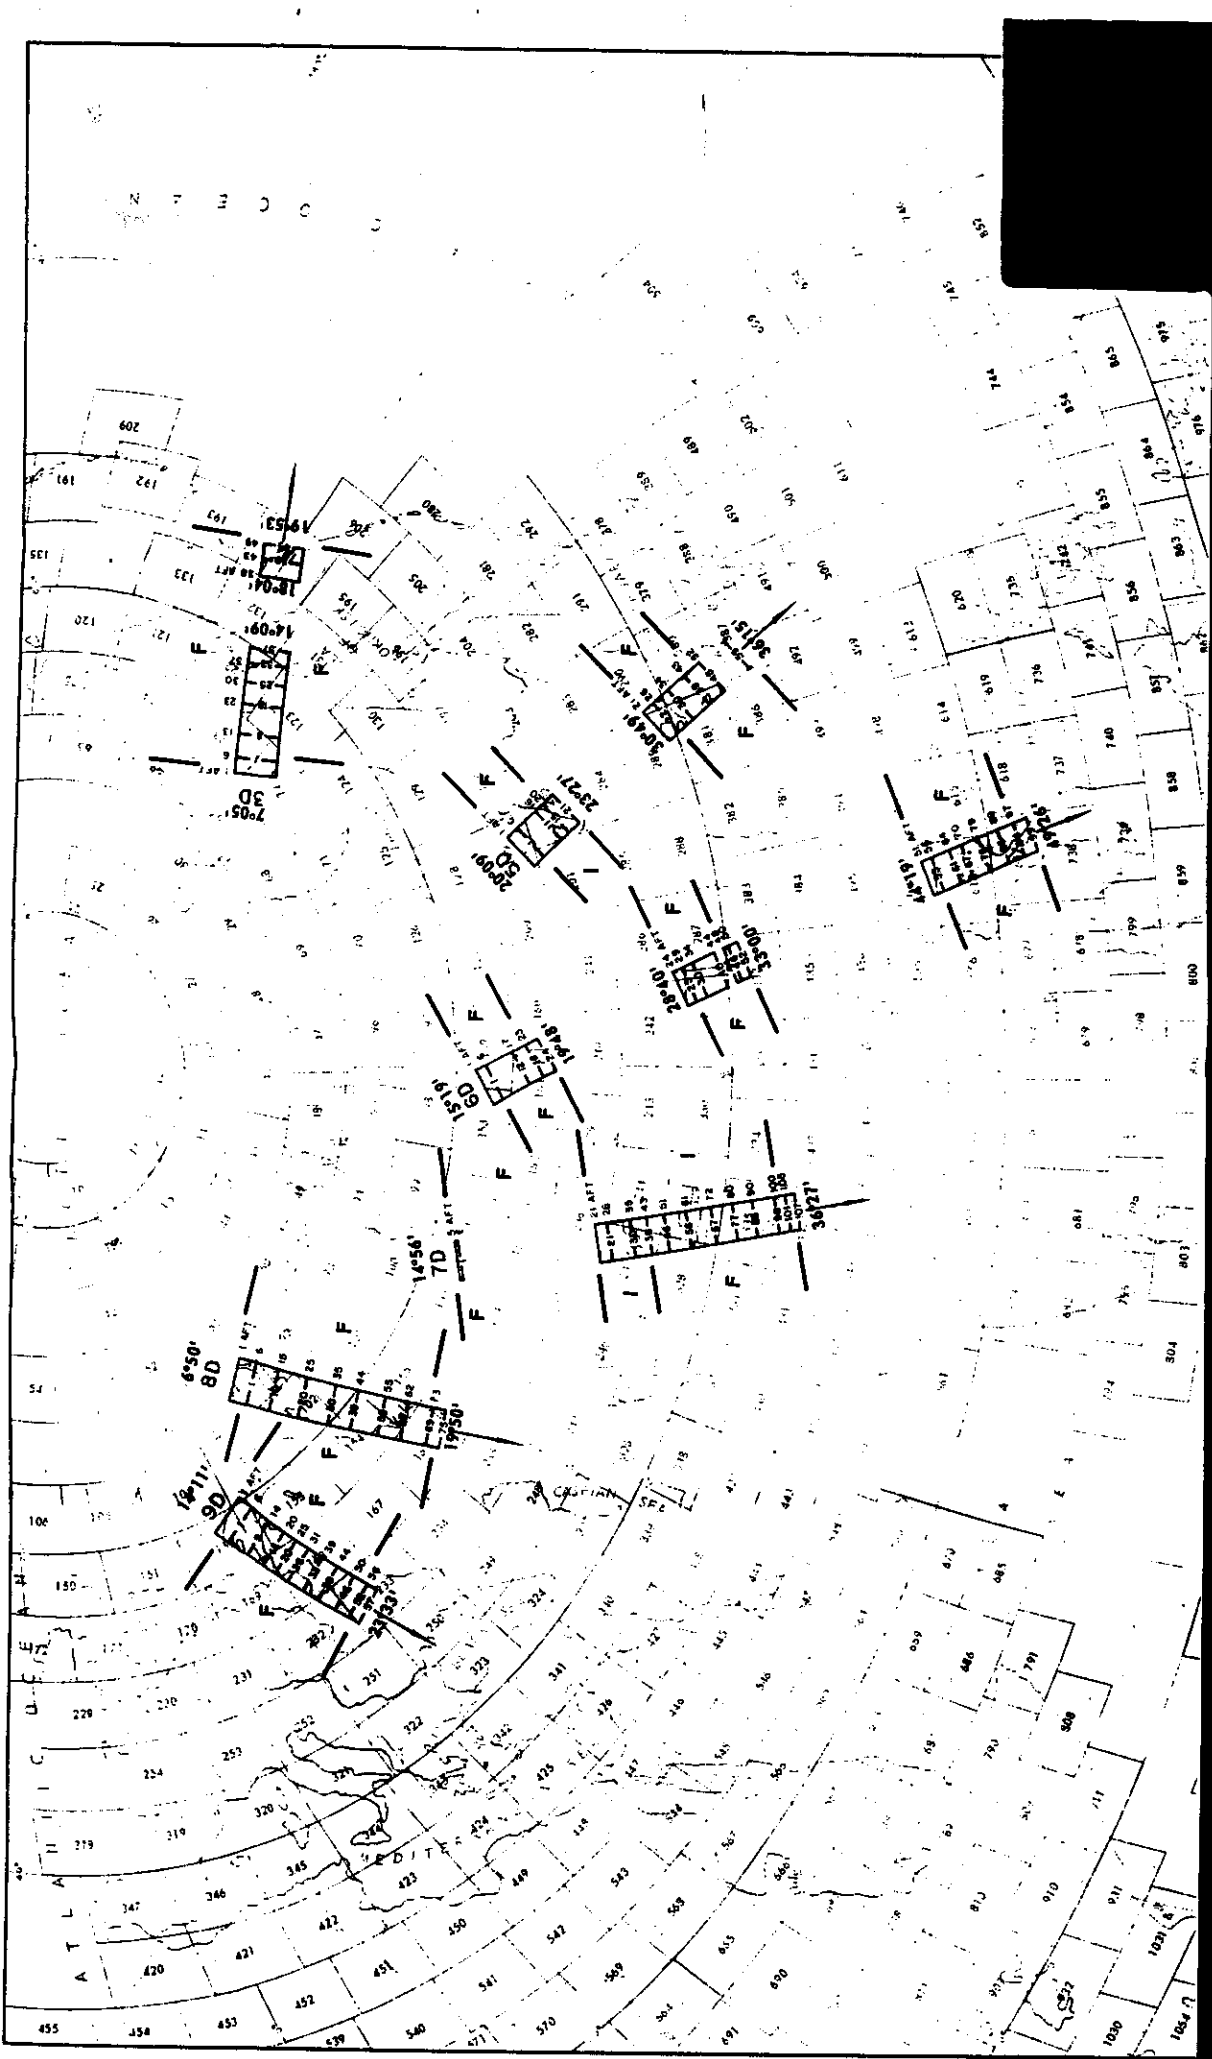
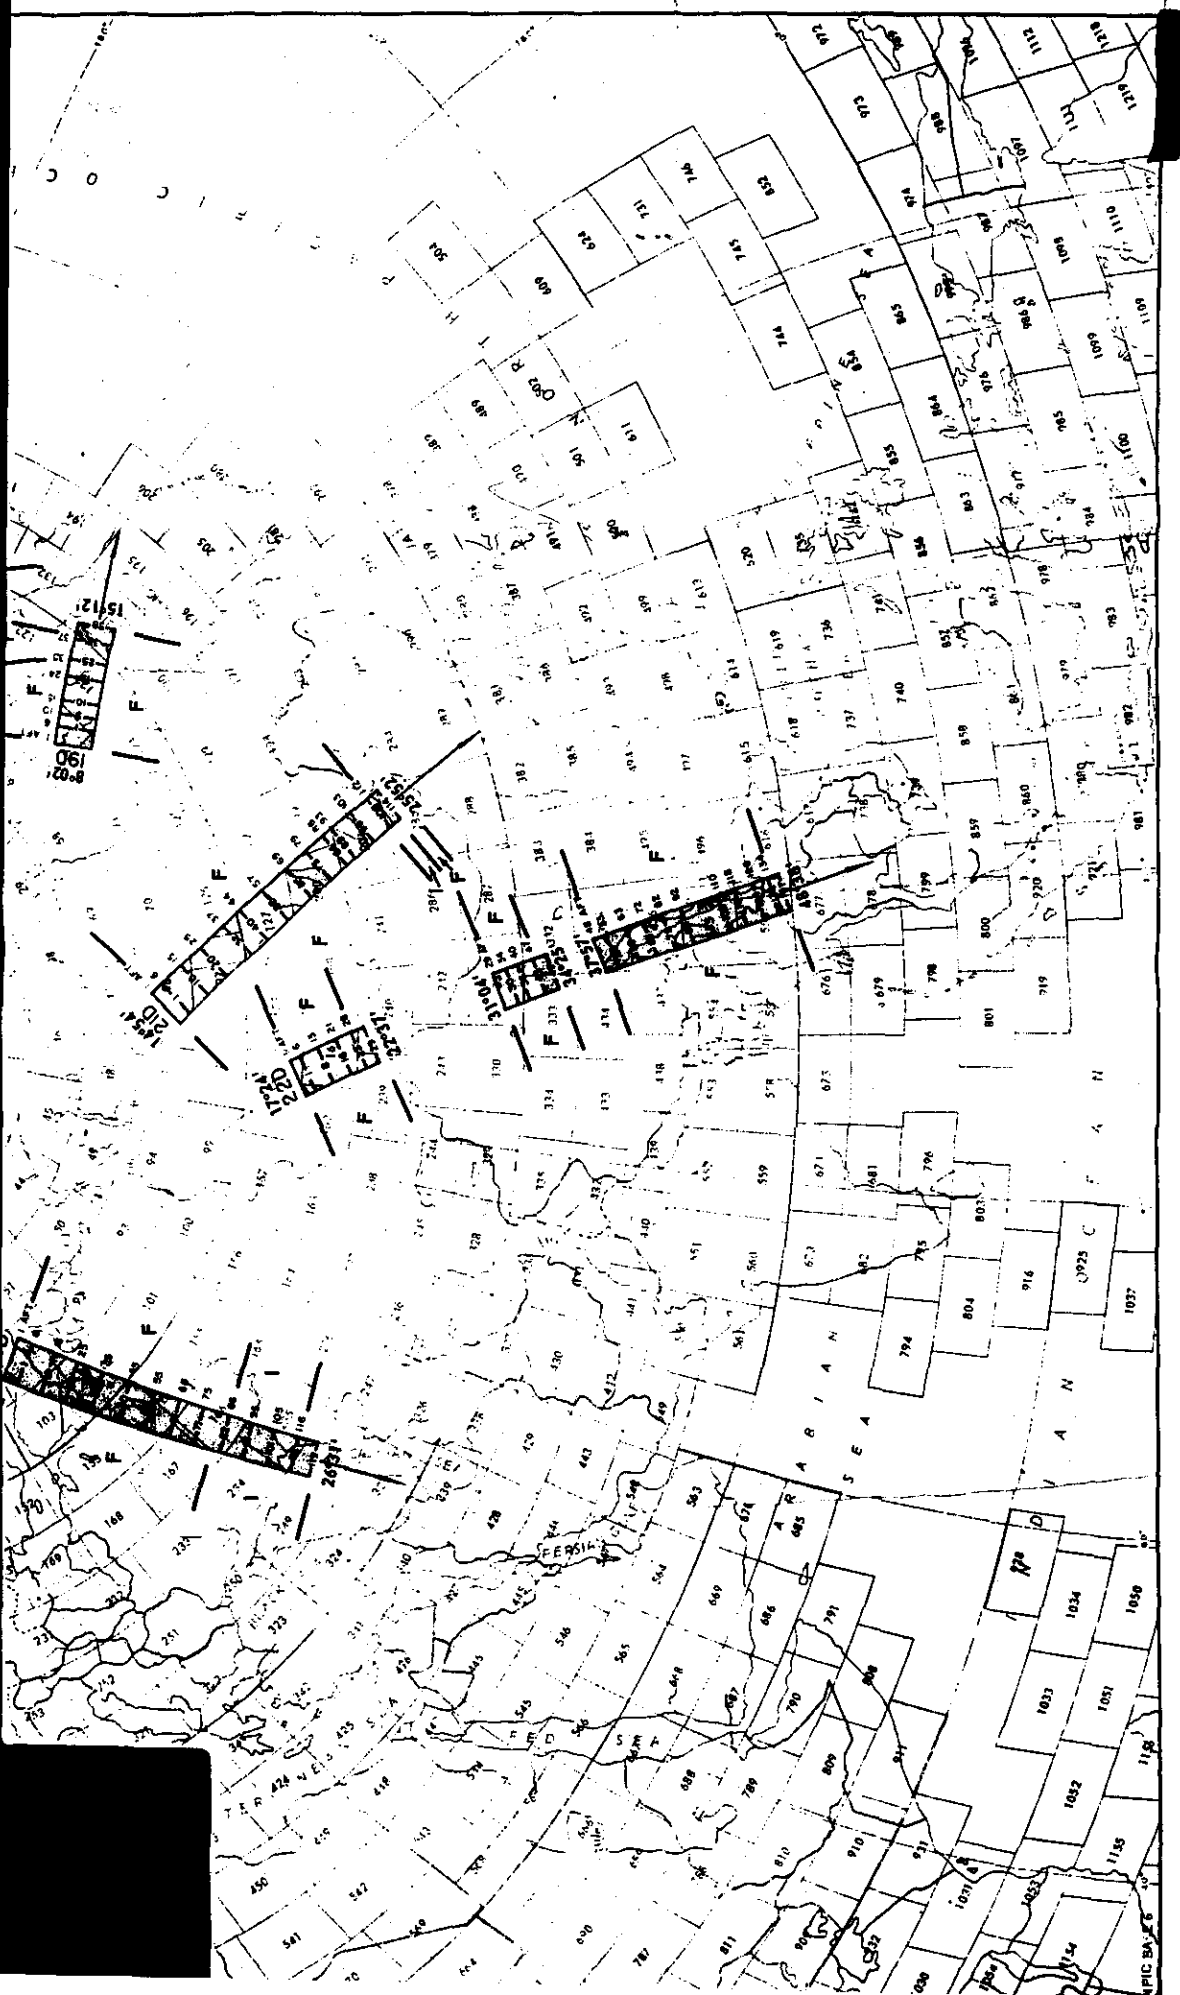
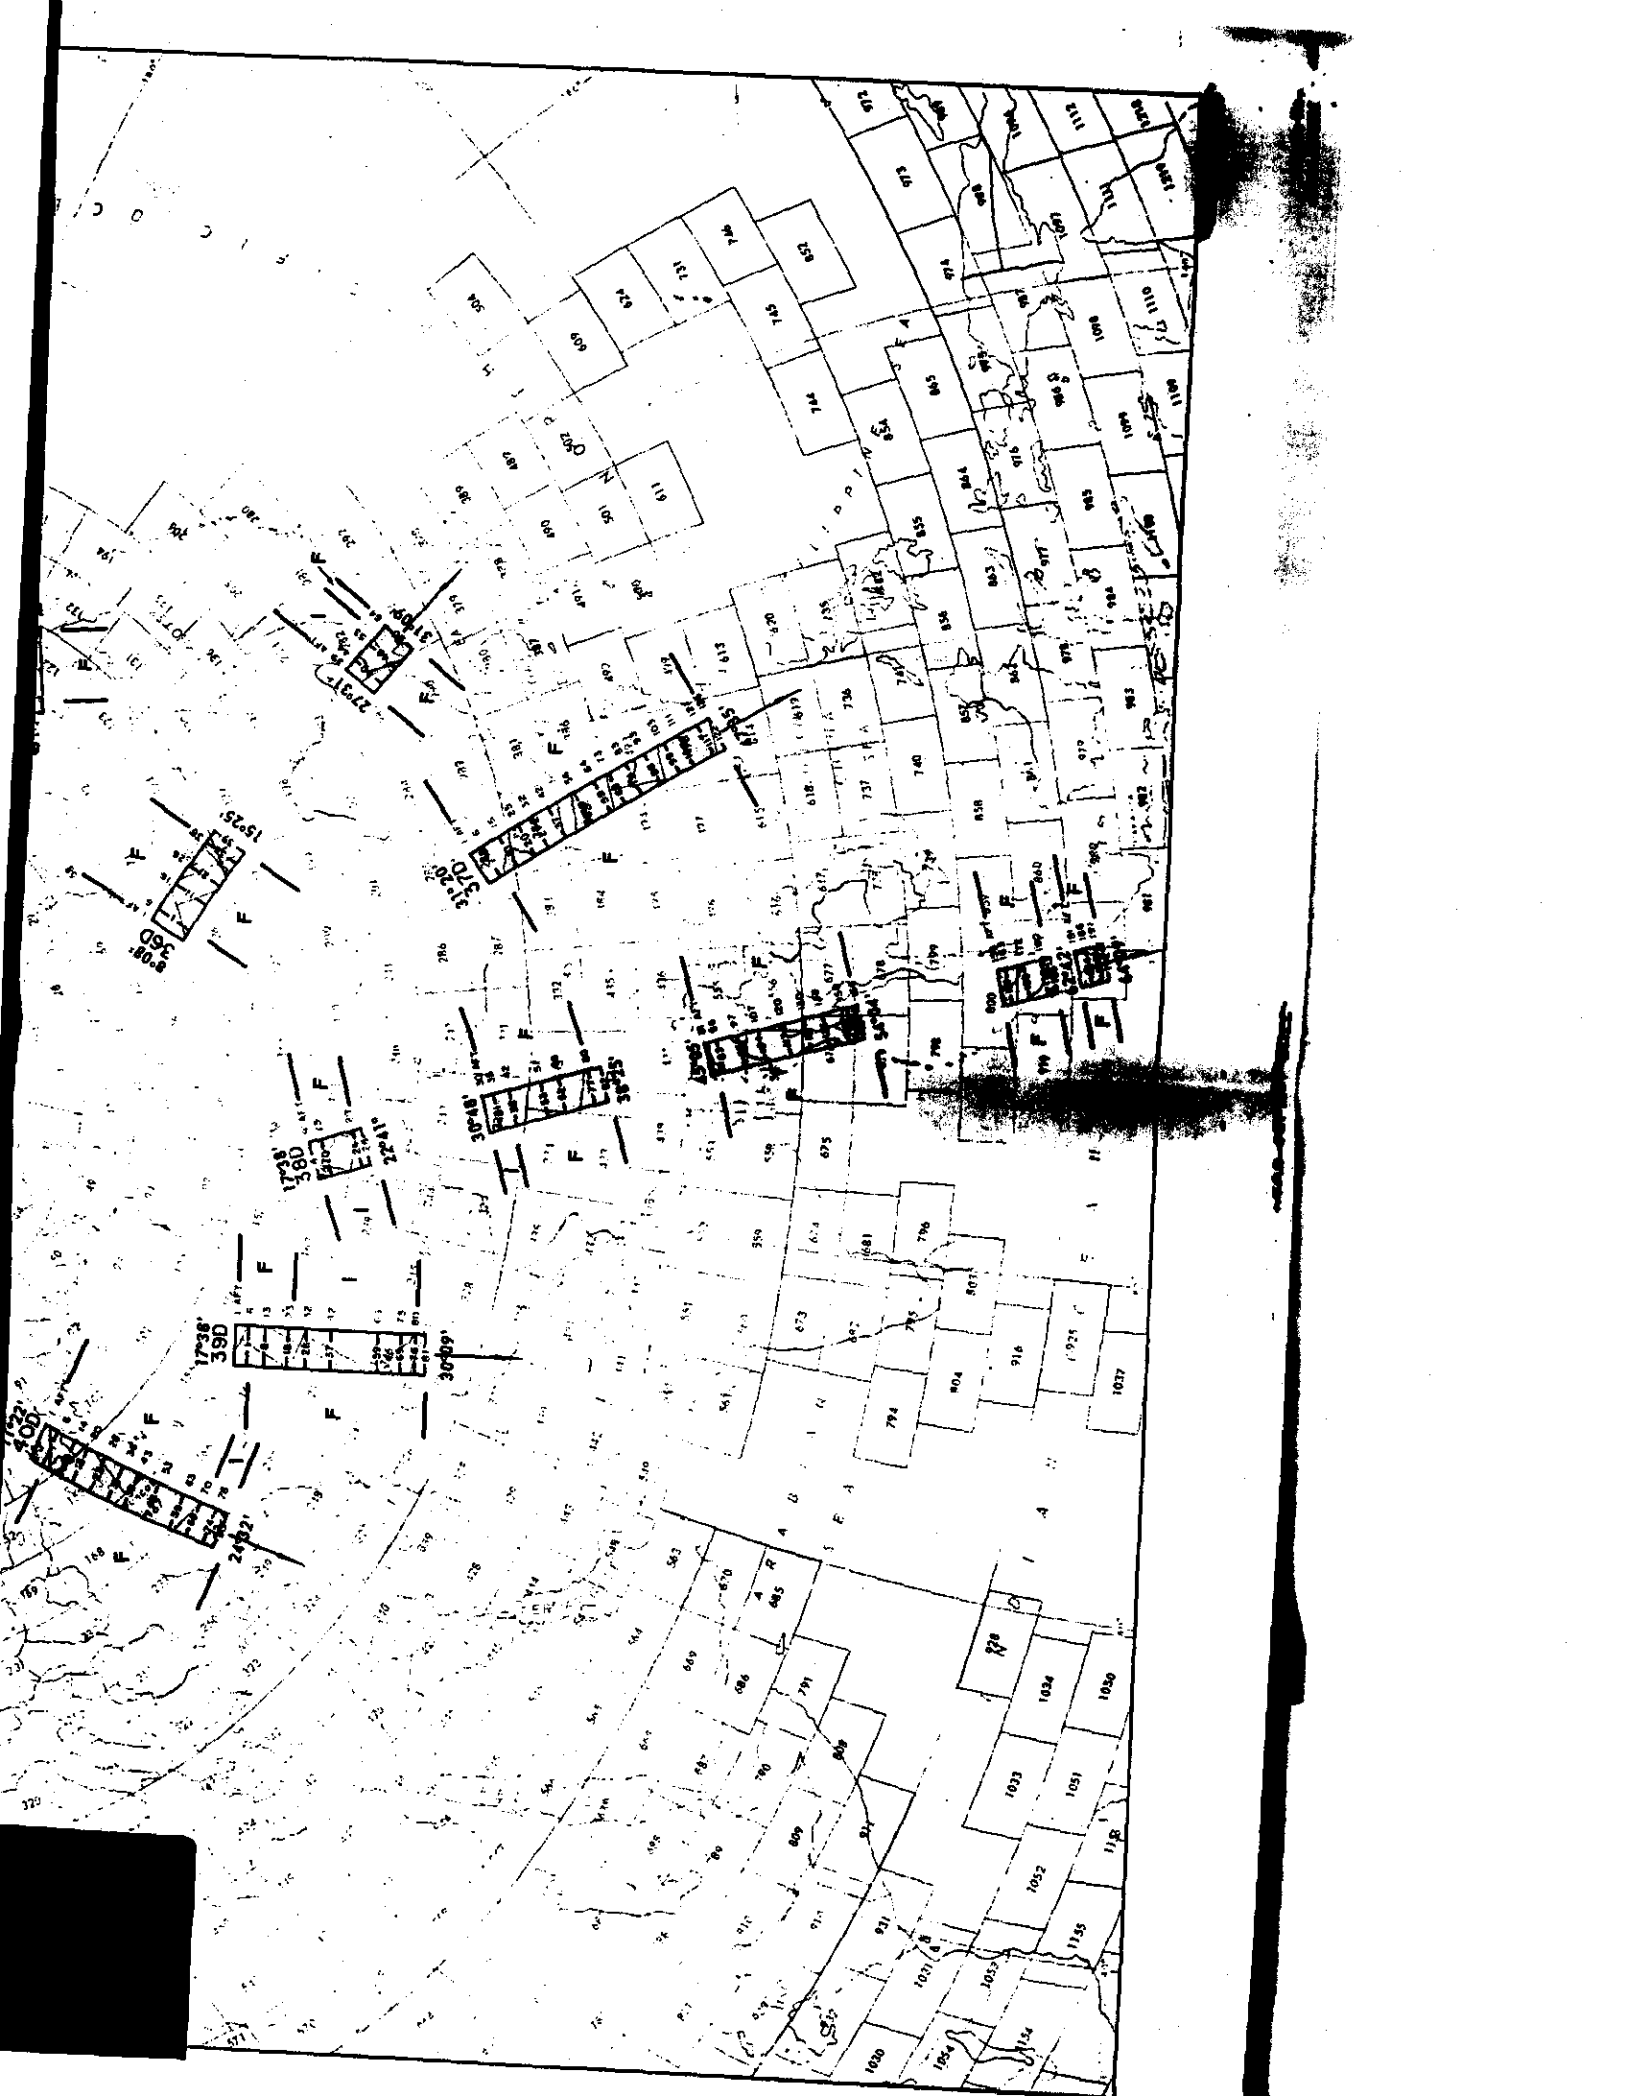
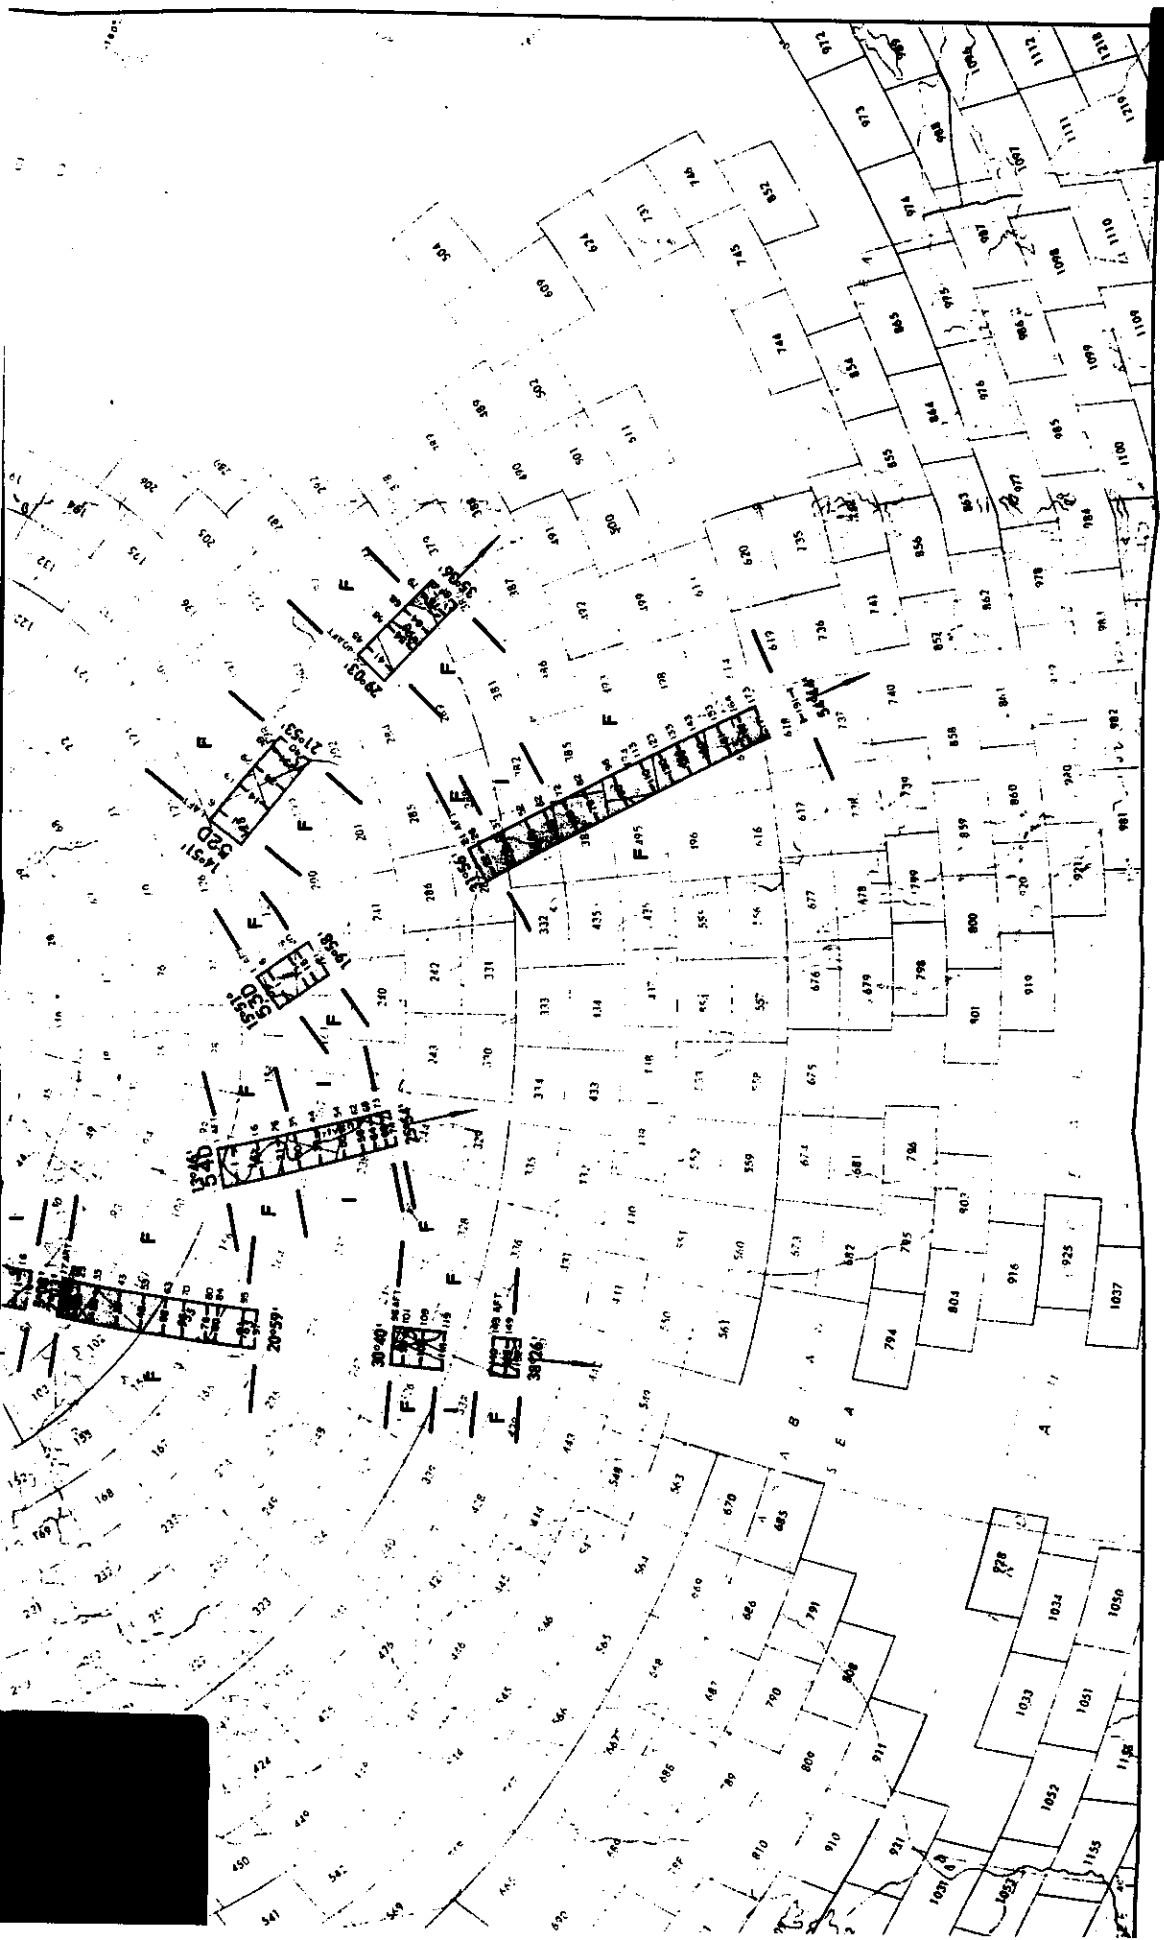
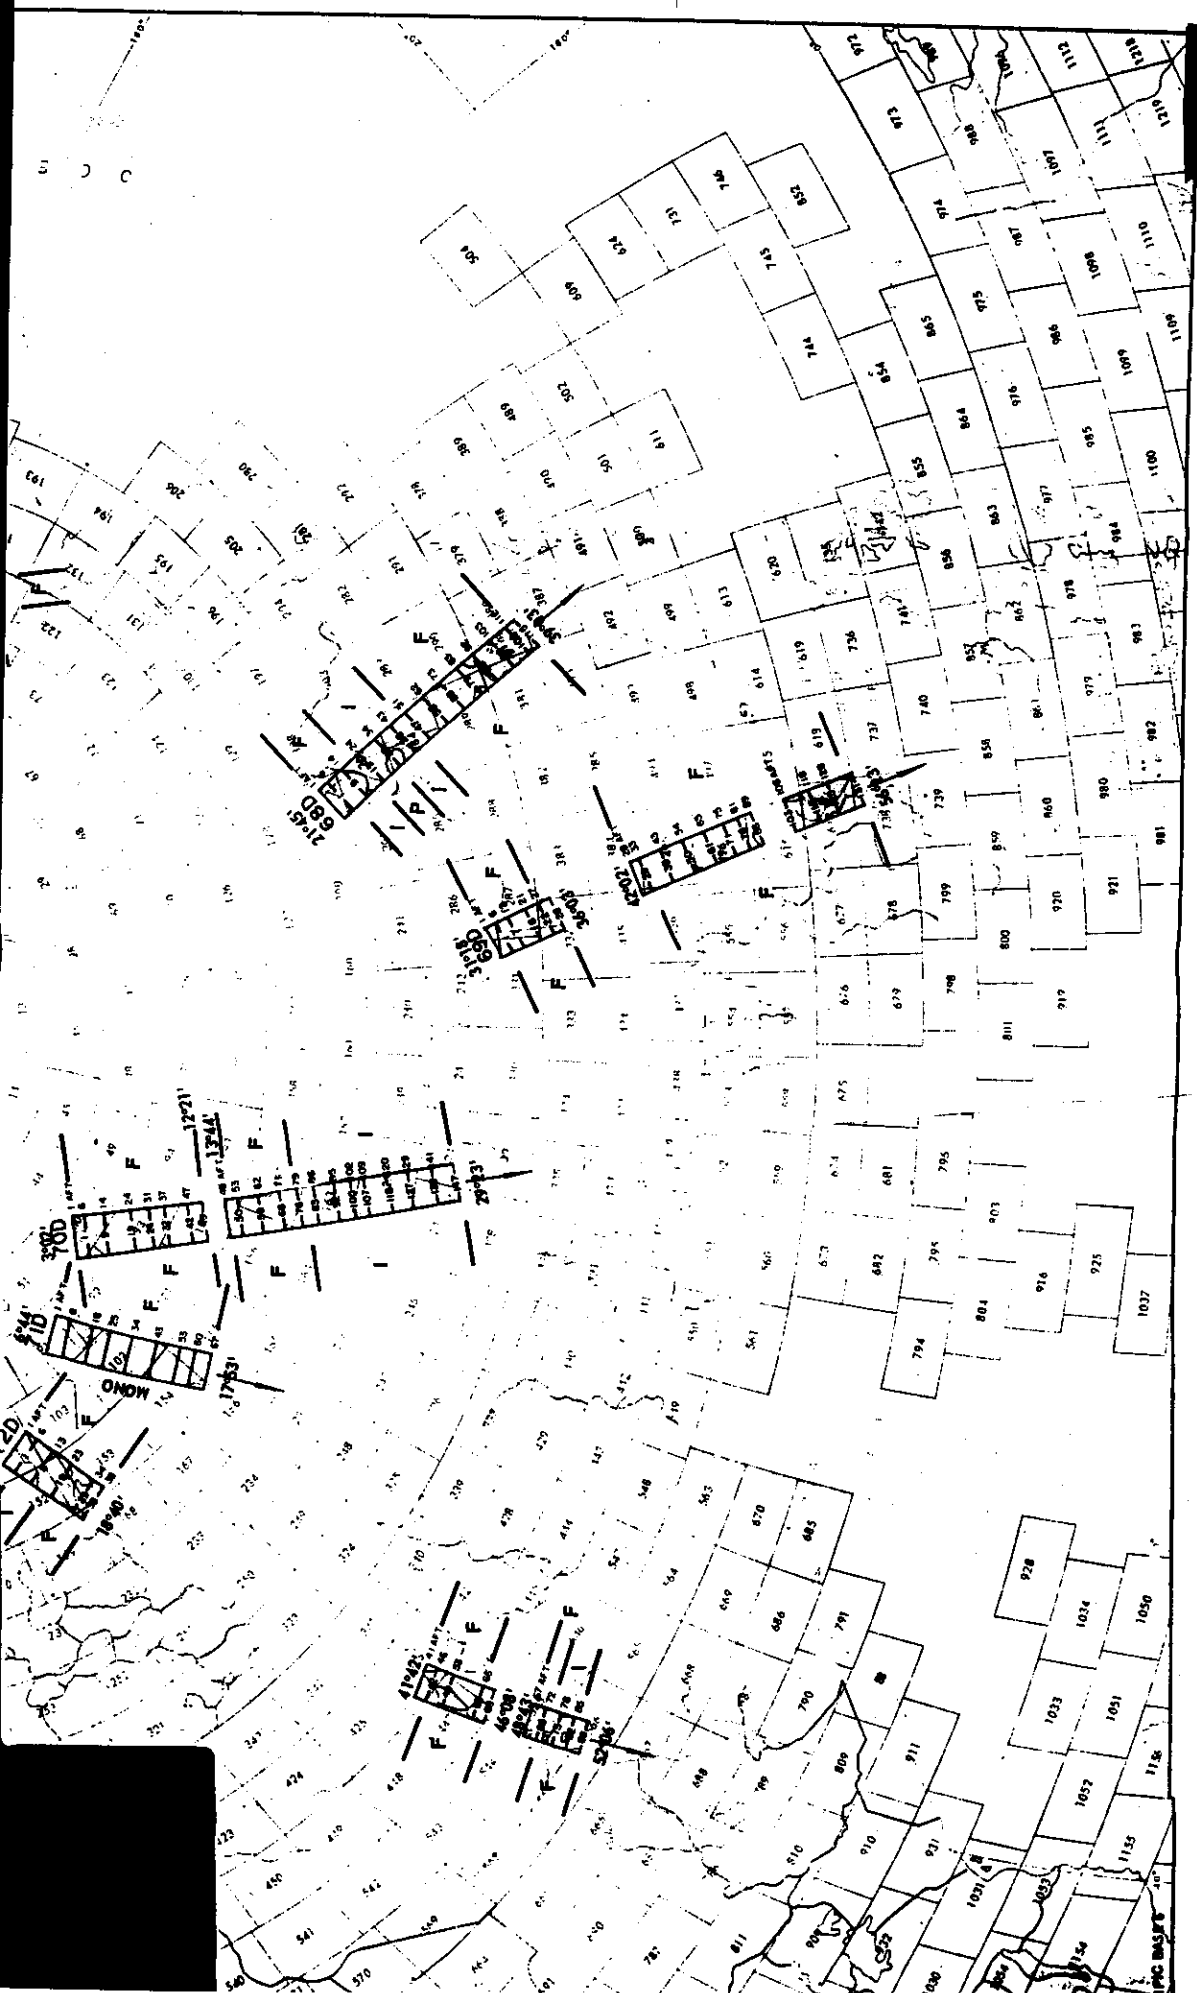
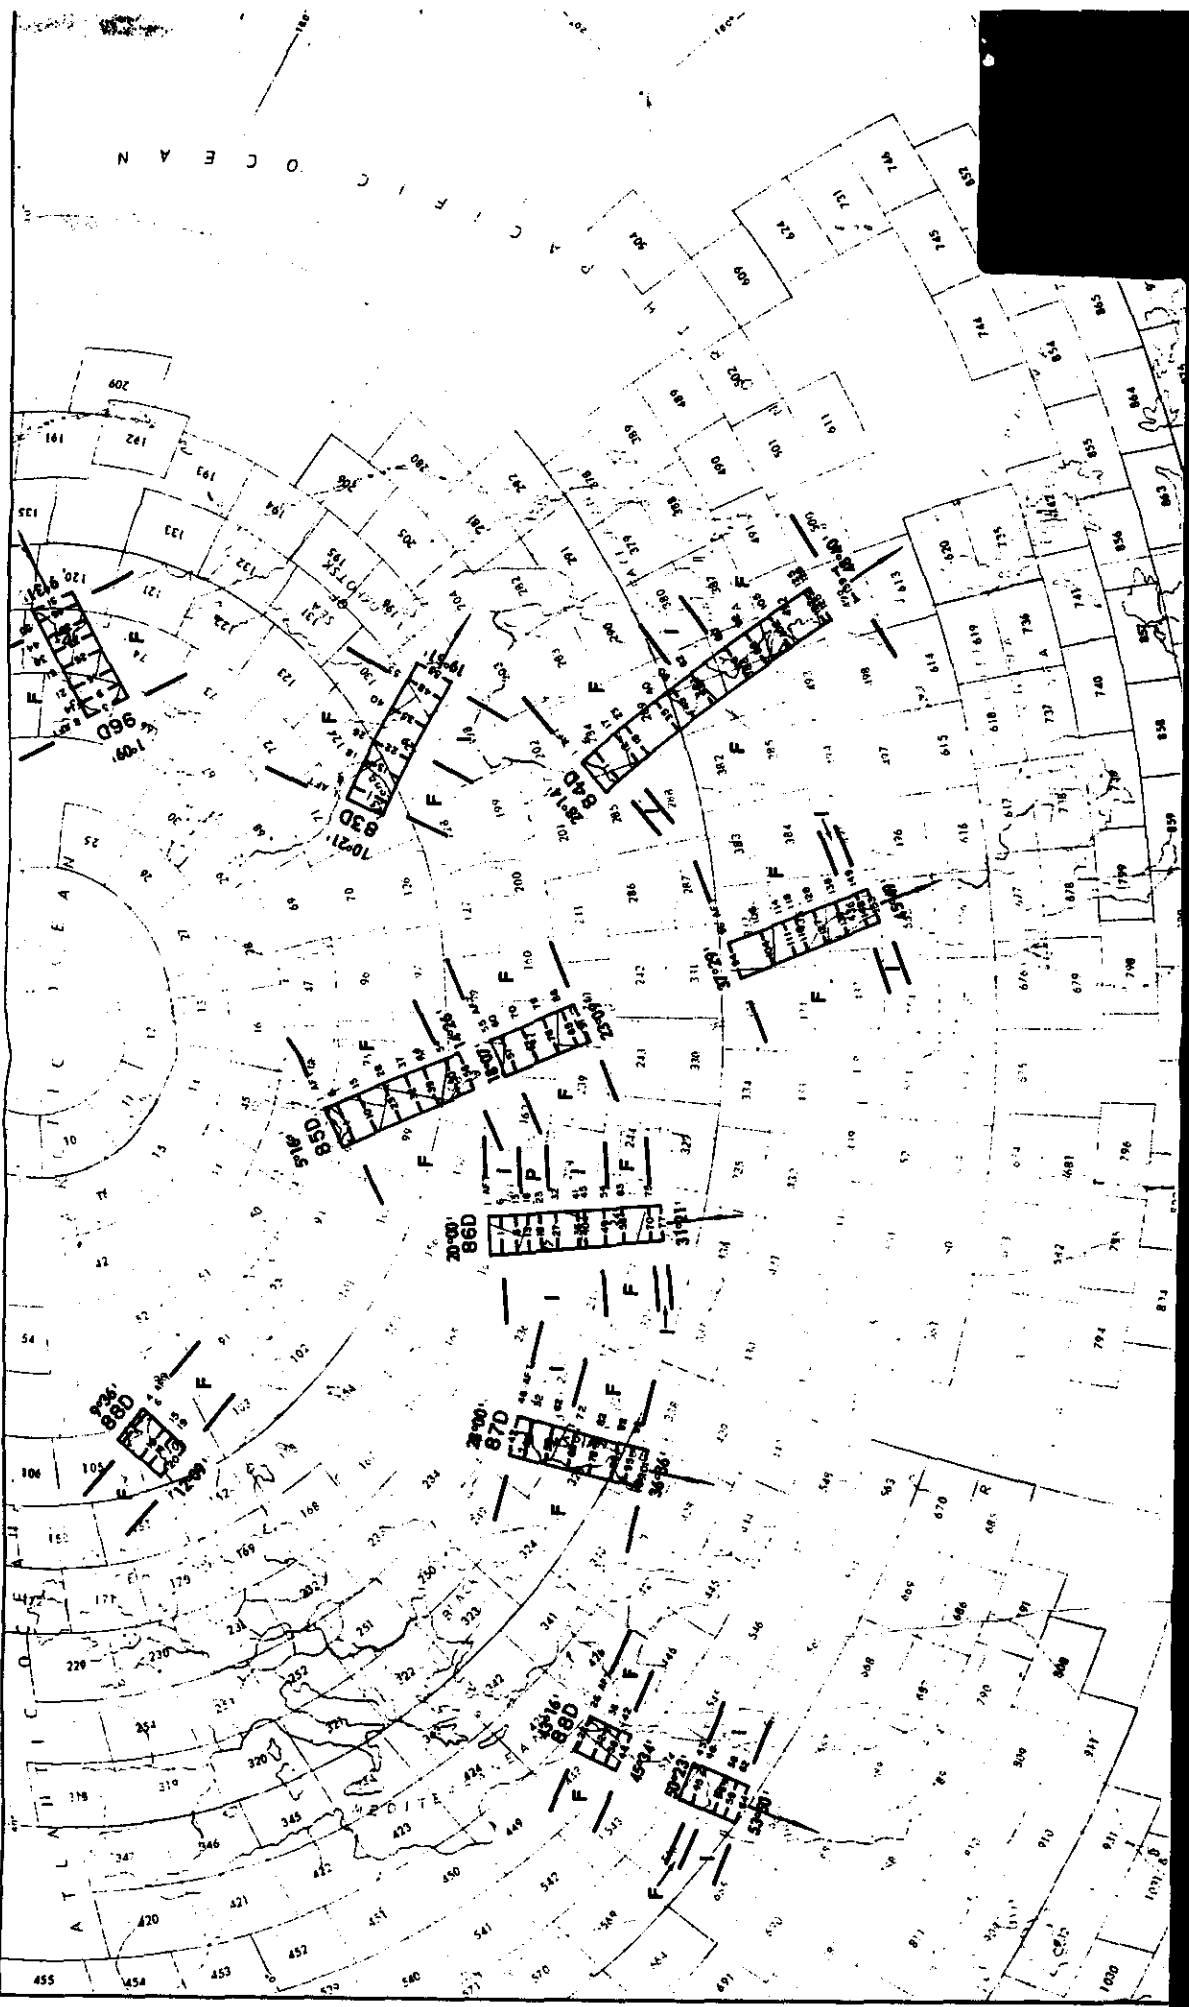
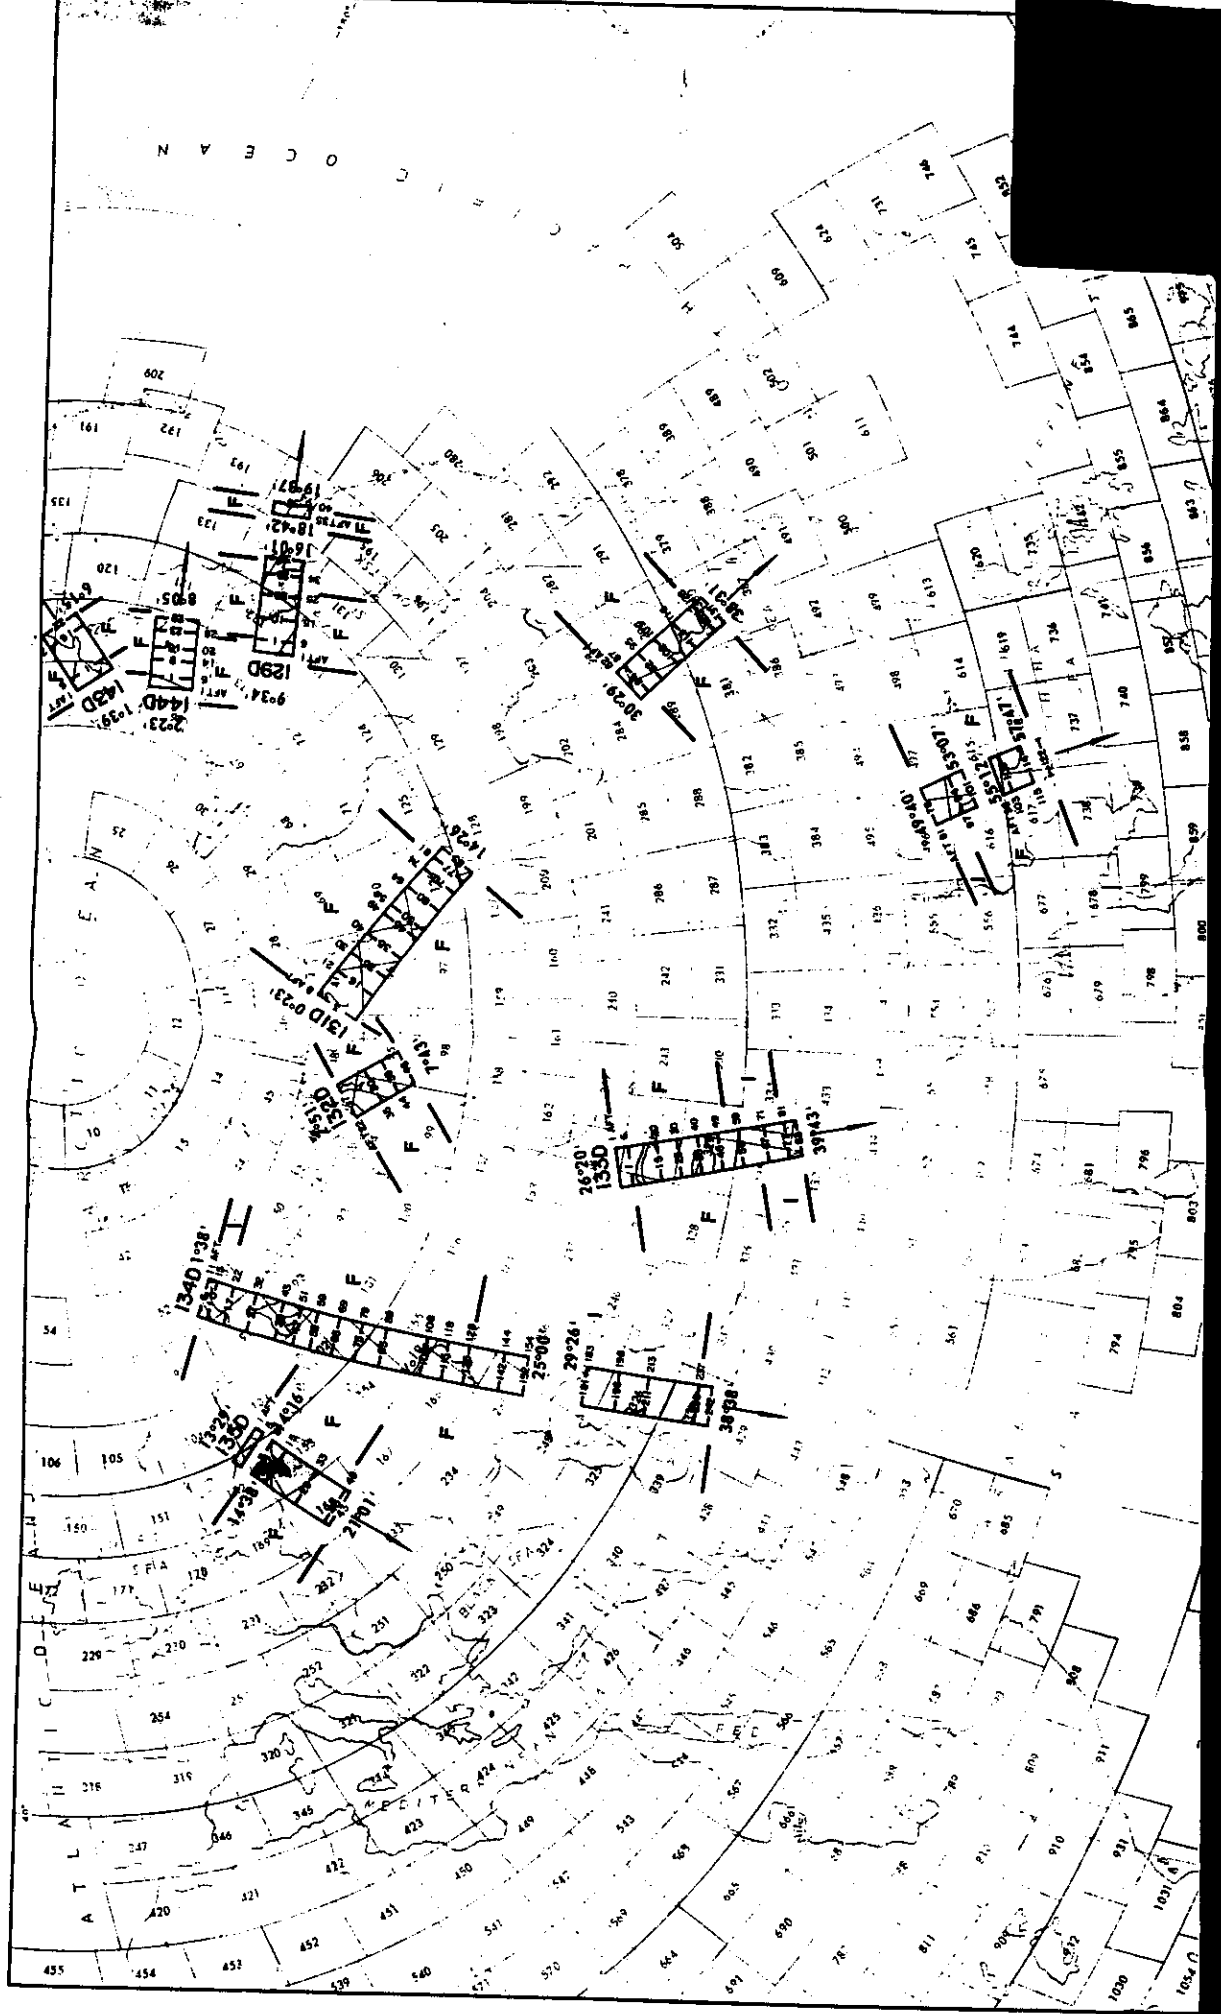
## APPENDIX G. GRAPHIC CORRELATION OF GEOGRAPHIC LATITUDE-LONGITUDE, SOLAR ELEVATION, PROCESSING LEVEL

1. The following pages provide a graphic illustration of the relation of geographic coordinates, solar elevations, and processing levels on each operational (descending) pass over the Eurasia land mass during Missions 1029-1 and 1029-2. The figure immediately above each pass number indicates the solar elevation at the beginning of the pass or part. The figure following each plotted pass or part represents the solar elevation at the end of that photographic operation. The letter designations on either side of each pass indicate the processing level changes -- F indicates a full level of development; I represents the intermediate level; and P indicates that the section of film was processed at the primary level of development. The letters to the right of a pass are pertinent to the processing level of slave (aft) camera film and the letters to the left of a pass pertain to the master (fwd) camera film.
